Roof Name: Upper Flat Roof
Roof Size: 49,140 sq. ft.
Est. Replacement Cost: \$196,560
Existing System Type: Ballasted EPDM
Year Installed: 1985 (Estimated)
Height: 30 feet
Slope: Slight
Interior Sensitivity: Normal
Drainage: Adequate
Currently Leaking? Unknown
History of Leaking? Yes

Existing Roof System Construction

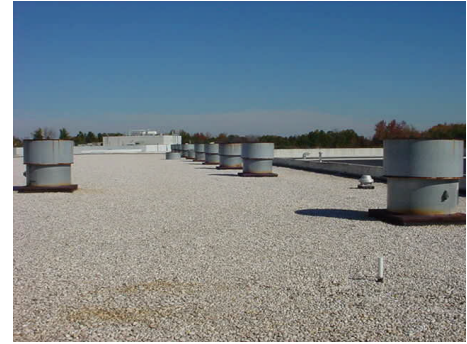
Drainage and Leak Details: The roof appeared to have adequate drainage toward the roof drains and no ponding water was noticed at the time of this inspection. It has been reported that leaks occur along the walls in the past. The current extent and location of "active" roof leaks was not known at the time of this inspection.
